ACTIVE BEACON COLLISION AVOIDANCE SYSTEM (BCAS) LOGIC PERFORMANCE DURING OPERATIONAL FLIGHT TESTS

R.A. TORNESE
A.L. MCFARLAND

The MITRE Corporation
McLean, Virginia 22102

JANUARY 1981

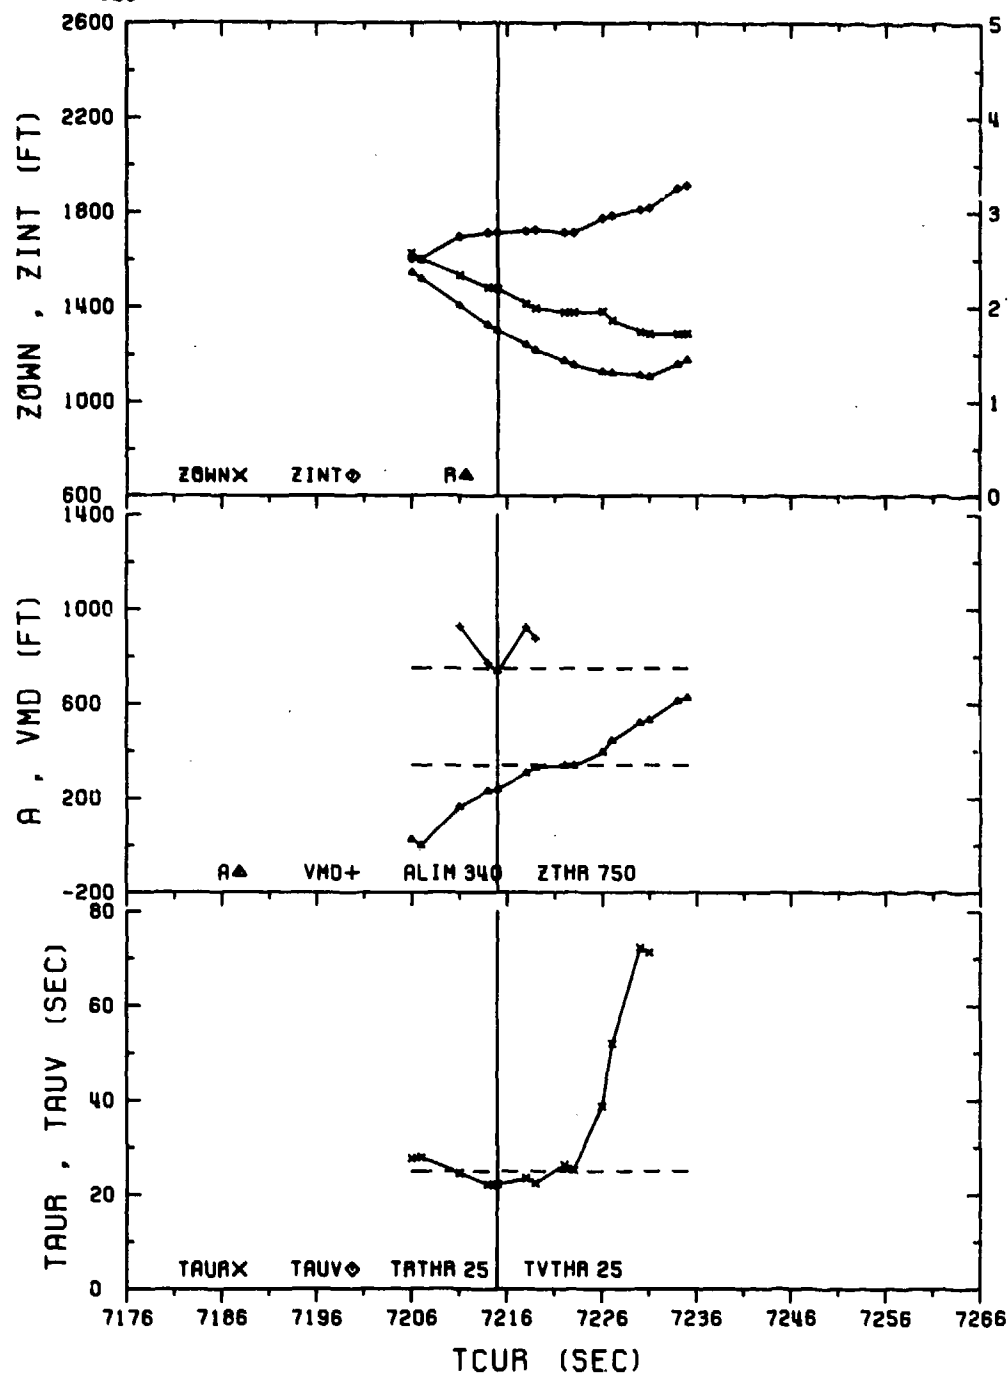
FIGURE 4-40
SEPARATION, TAU PLOTS FOR ENCOUNTER 17 AT SAN FRANCISCO

The advisory for the second encounter came up at system time 7012 (see Figures 4-40 and 4-41). The BCAS aircraft was descending through 1300 ft while the third aircraft was climbing through 1500 ft. A don't climb advisory was given to the BCAS aircraft. As the aircraft continued to diverge vertically, the advisory was dropped.

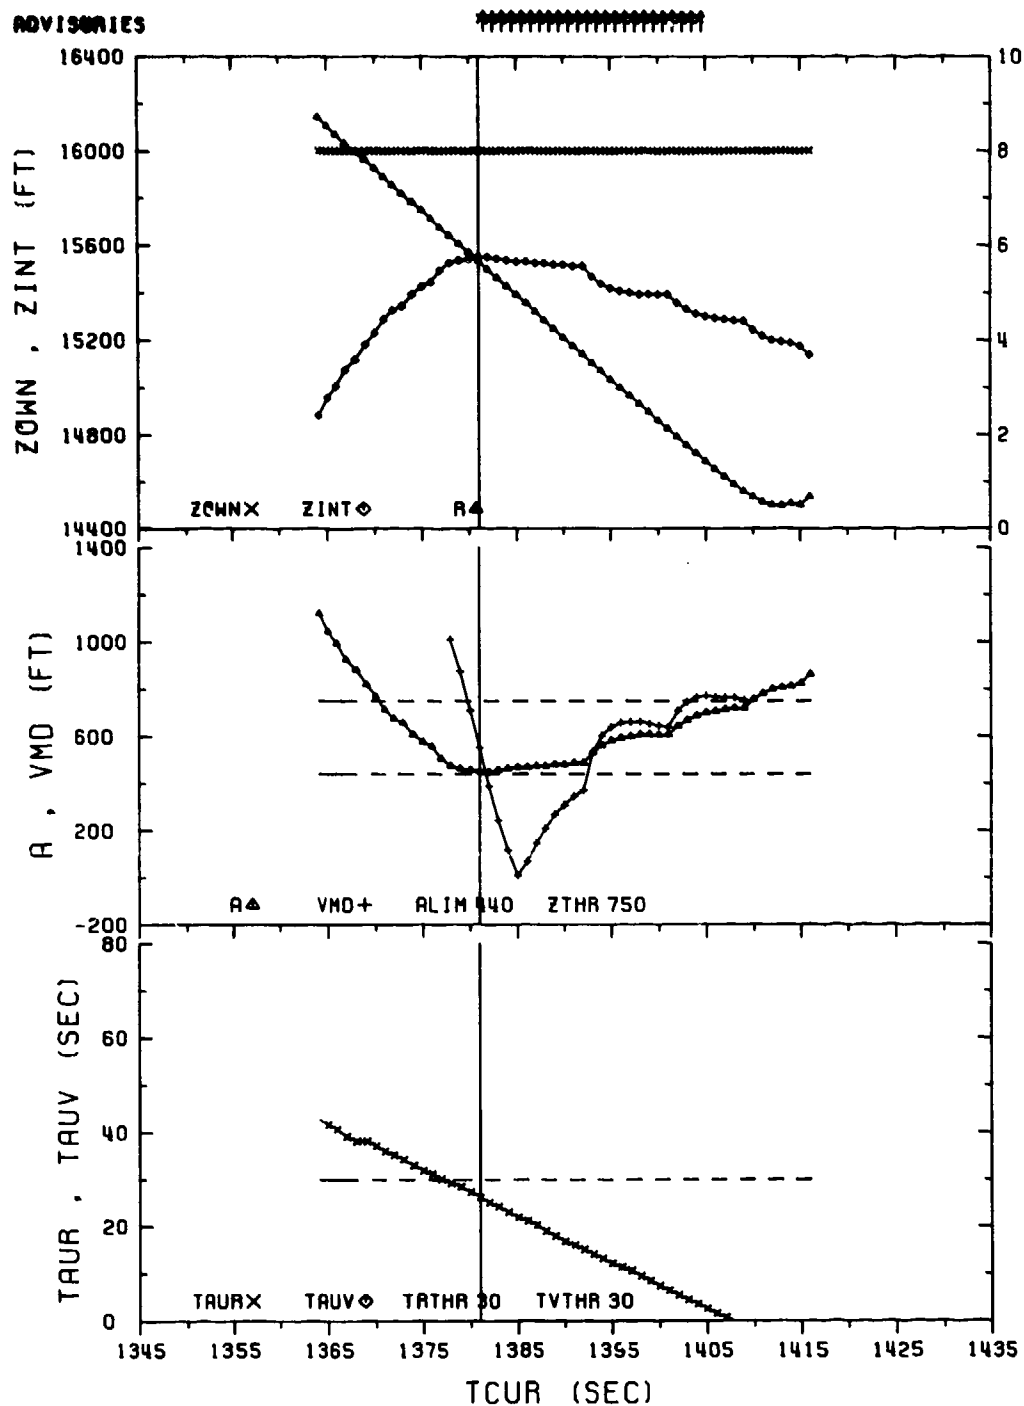
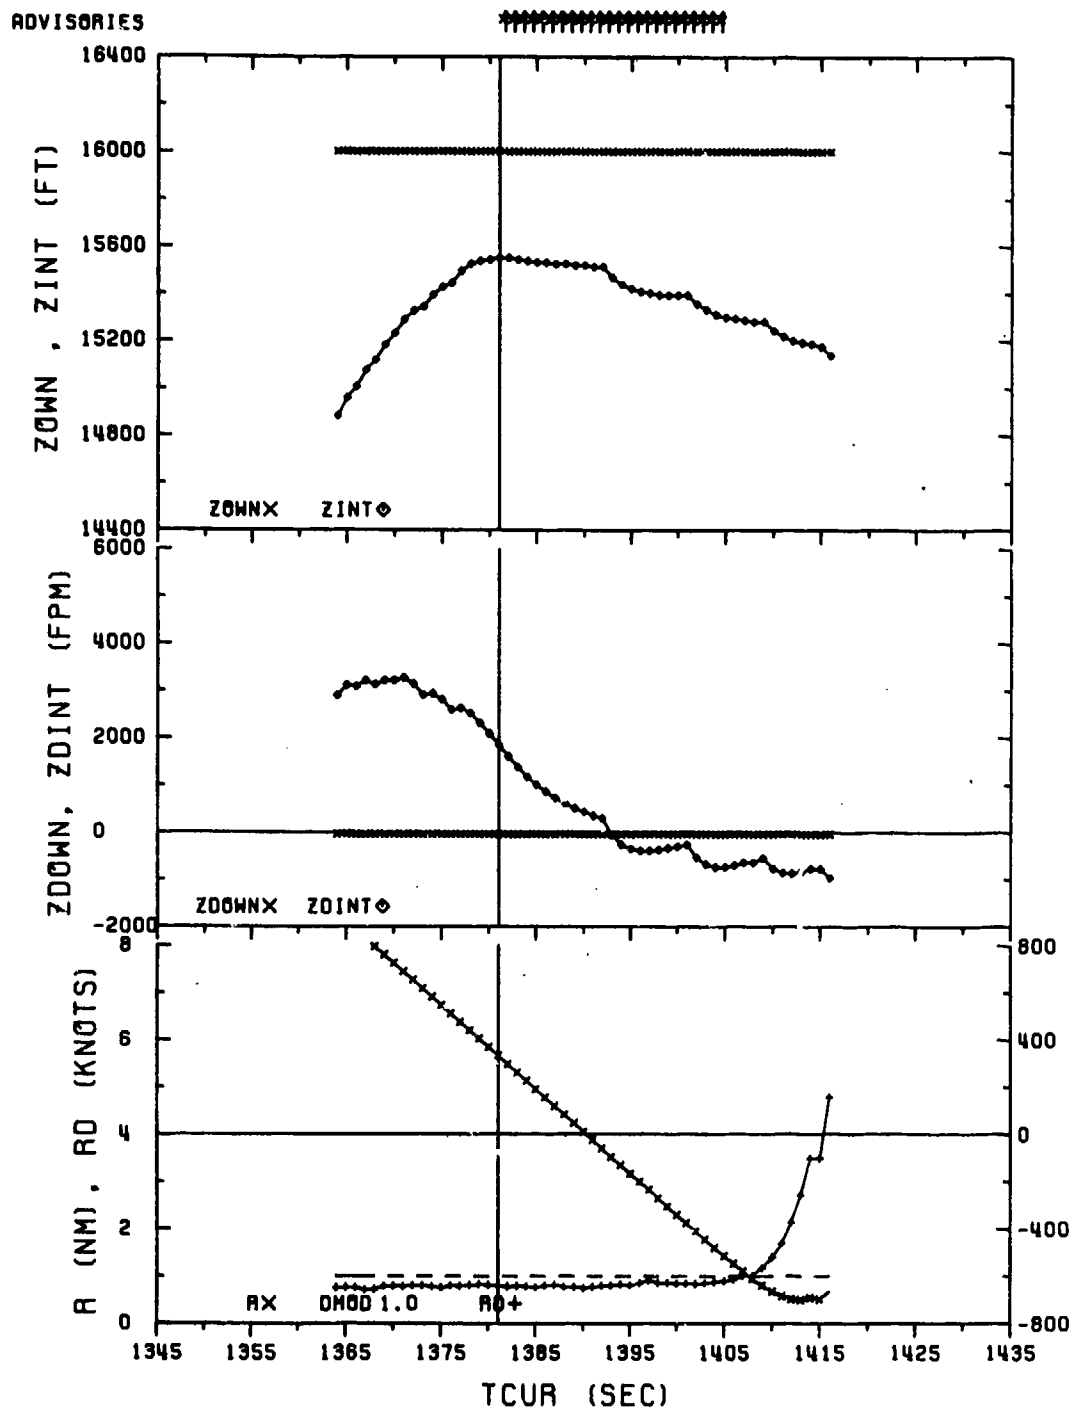
The DC9 had begun to level-off just before the advisory was calculated. However, because of tracker lag, the vertical tracker was still showing a climb. During the five second hold on the don't climb advisory, the vertical tracker began to catch up with the DC9's true vertical rate. VMD decreased towards zero. However, at this point, since the intruder's vertical velocity was below 1000 fpm, the unequipped intruder logic was disabled. The current separation, A, was used to choose the

FIGURE 4-42
SEPARATION, TAU PLOTS FOR ENCOUNTER 18 ON 4 AUGUST

FIGURE 4-43
SEPARATION, RATE PLOTS FOR ENCOUNTER 18 ON 4 AUGUST

advisory. Therefore, the negative advisory, don't climb, remained. The DC9 then descended towards 15,000 ft. The advisory dropped when VMD became greater than ZTHR.

The impact that the vertical maneuver by the intruder had on the BCAS logic is seen in Figure 4-42. When the sense of the advisory was being selected, the BCAS logic was predicting that the intruder would be almost 700 feet above the BCAS aircraft at the closest approach. This is indicated by the value of VMD at time 1380, since the BCAS aircraft is level. In reality, the intruder was 800 feet below the BCAS aircraft at closest approach, as indicated by the value of A at about time 1412. This represents a 1500 ft prediction error, which is a graphic illustration of the hazards of predicting too far into the future. In contrast, the prediction with level 4 parameters (Figure 4-46) was in error by 630 ft -- less than half of the level 5 number.

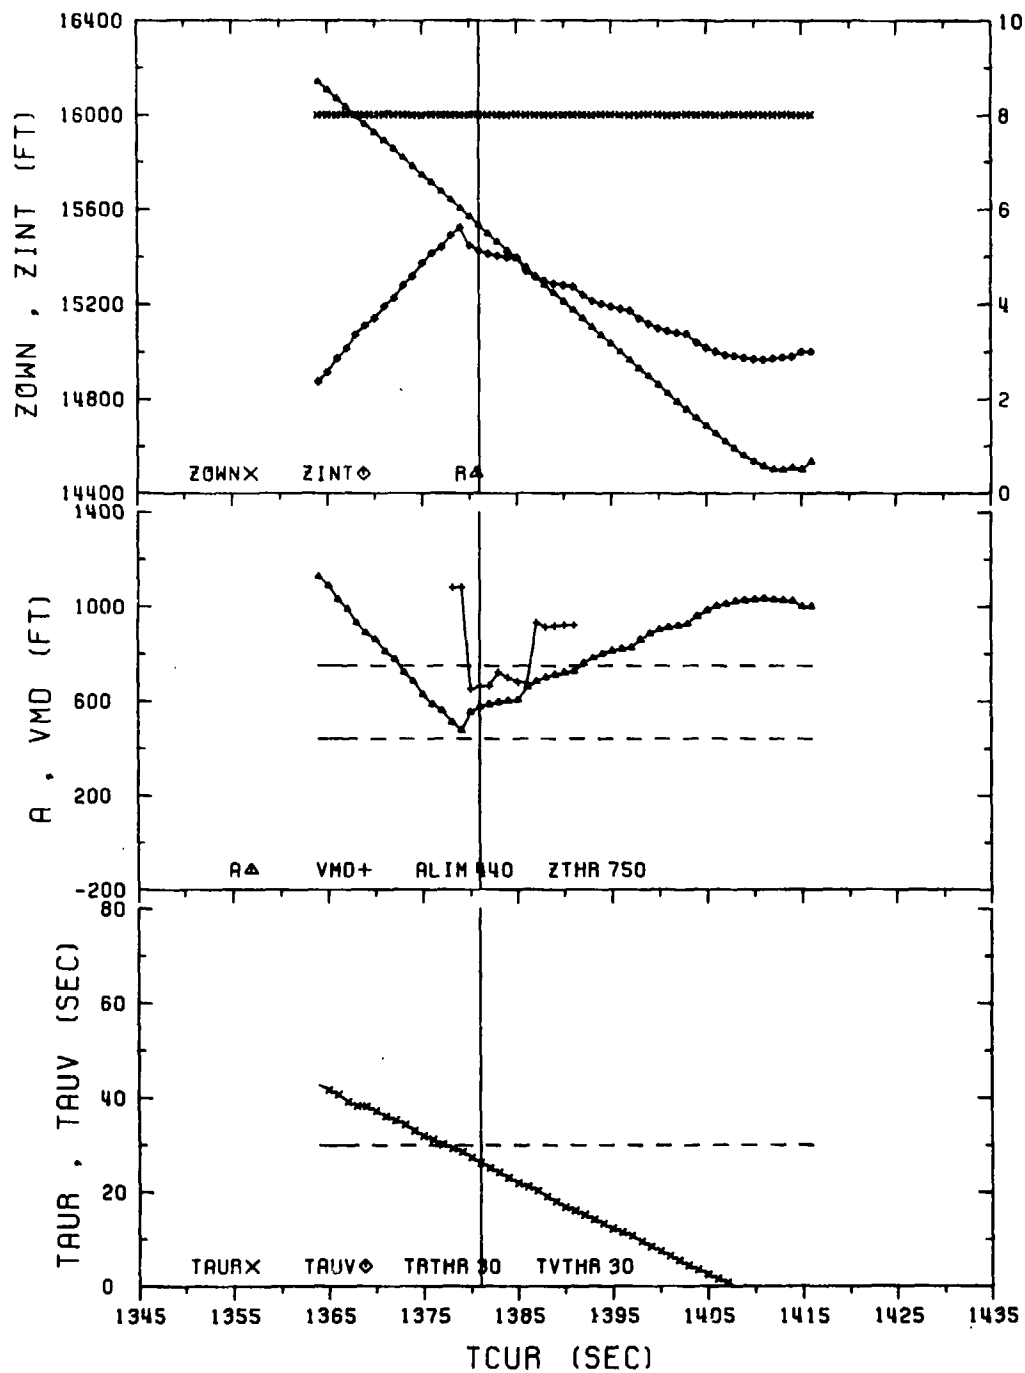
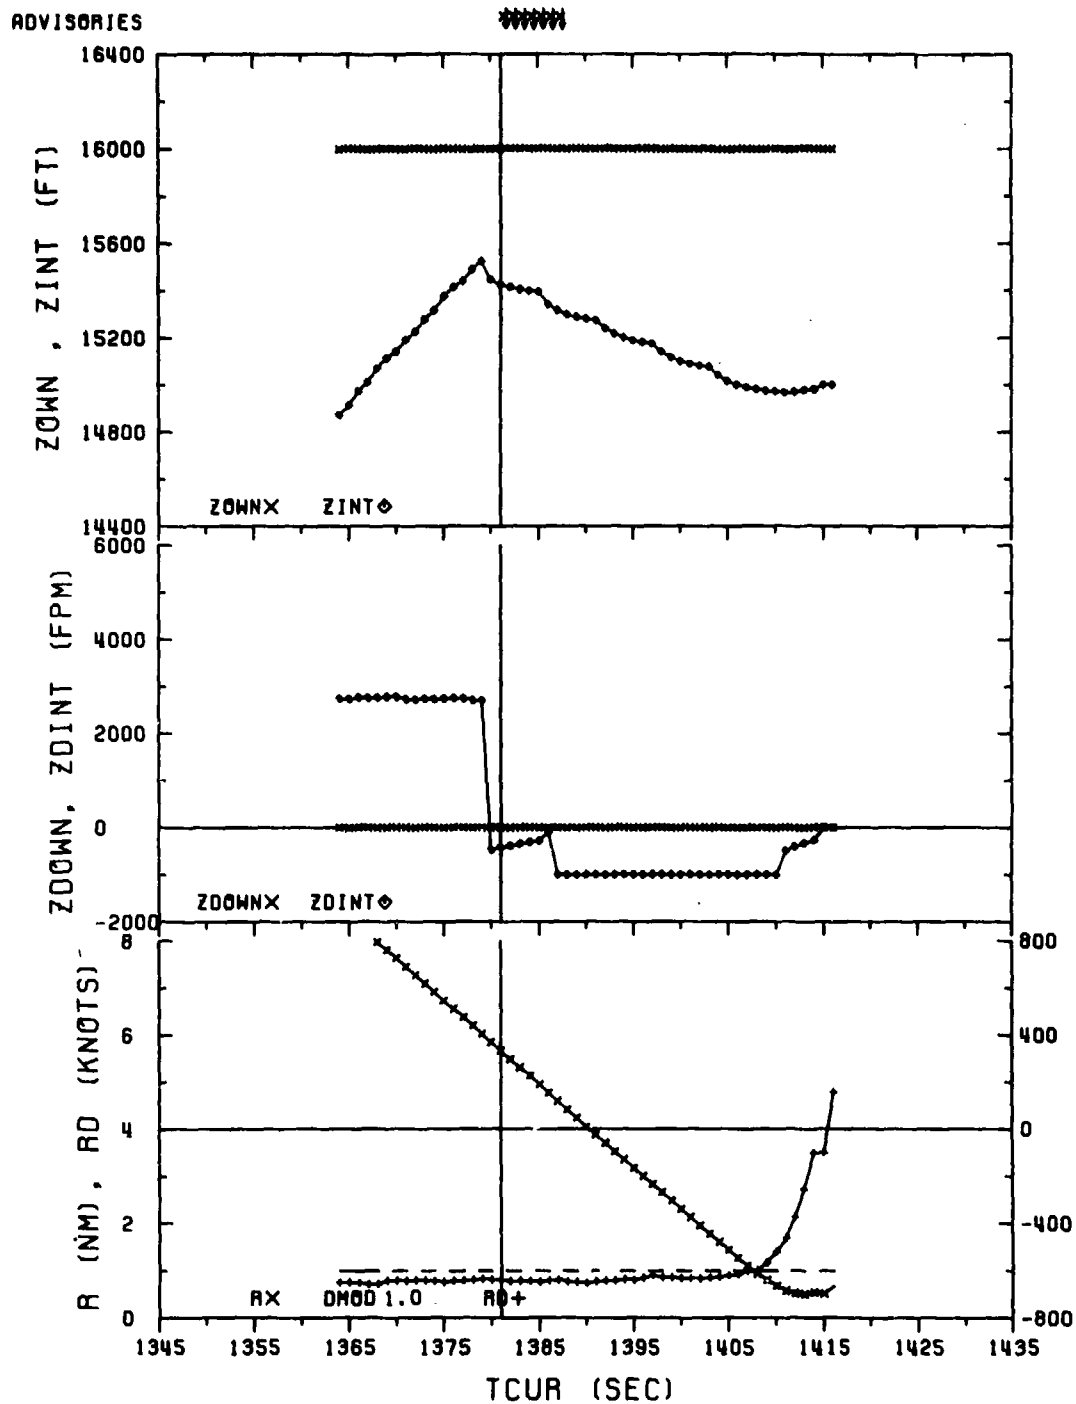
FIGURE 4-44
SEPARATION, TAU PLOTS FOR
4 AUGUST ENCOUNTER USING NON-LINEAR TRACKER

FIGURE 4-45
SEPARATION, RATE PLOTS FOR
4 AUGUST ENCOUNTER USING NON-LINEAR TRACKER

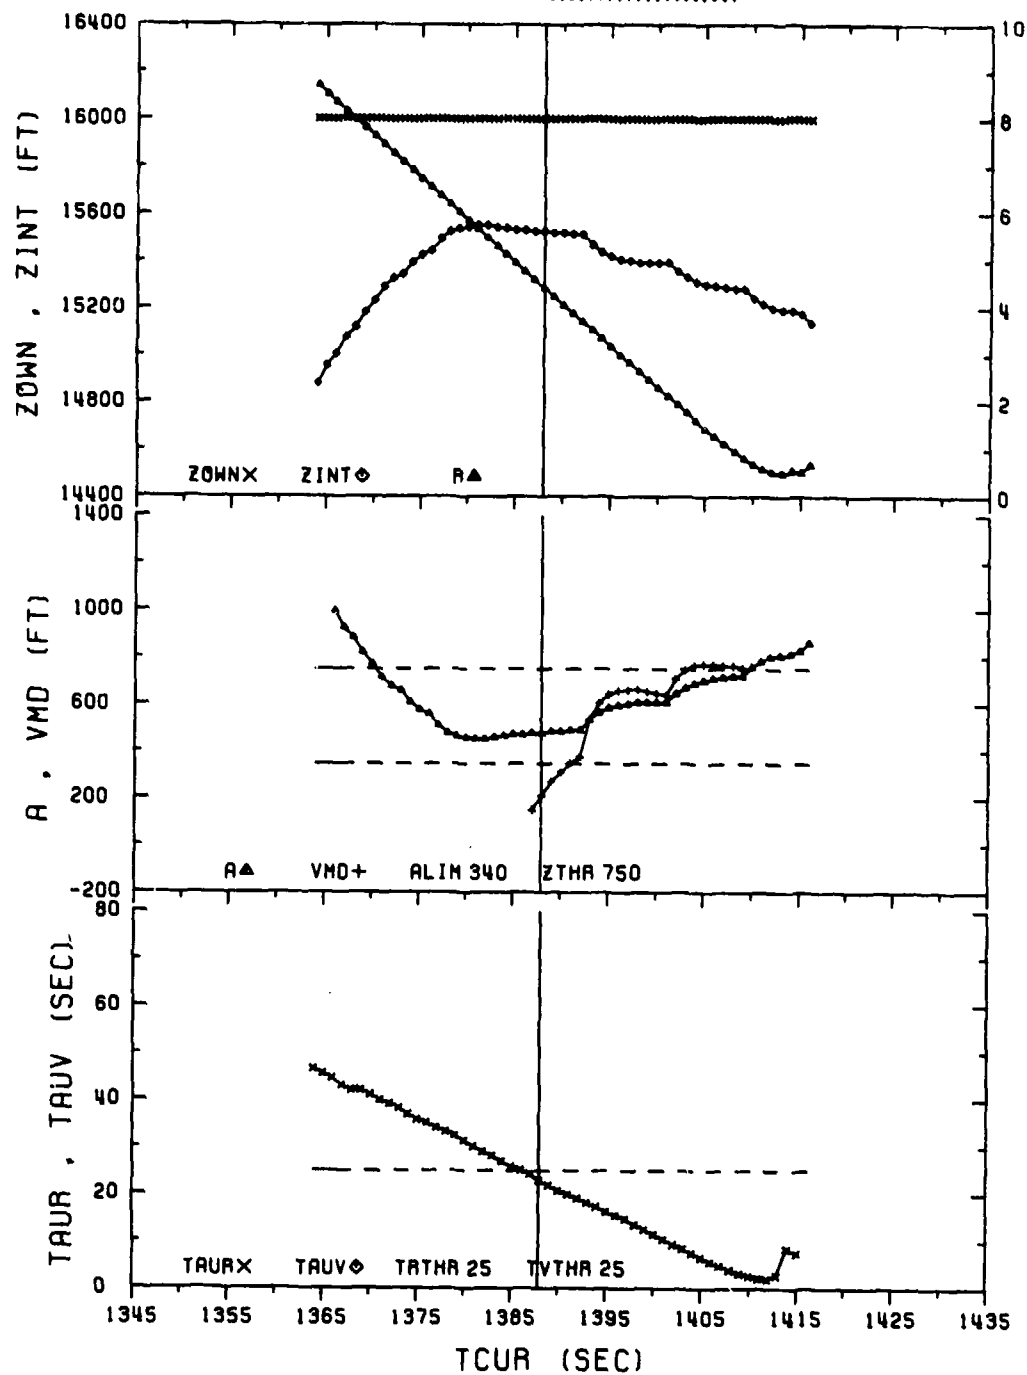
FIGURE 4-46
SEPARATION, TAU PLOTS FOR
4 AUGUST ENCOUNTER USING SENSITIVITY LEVEL 4

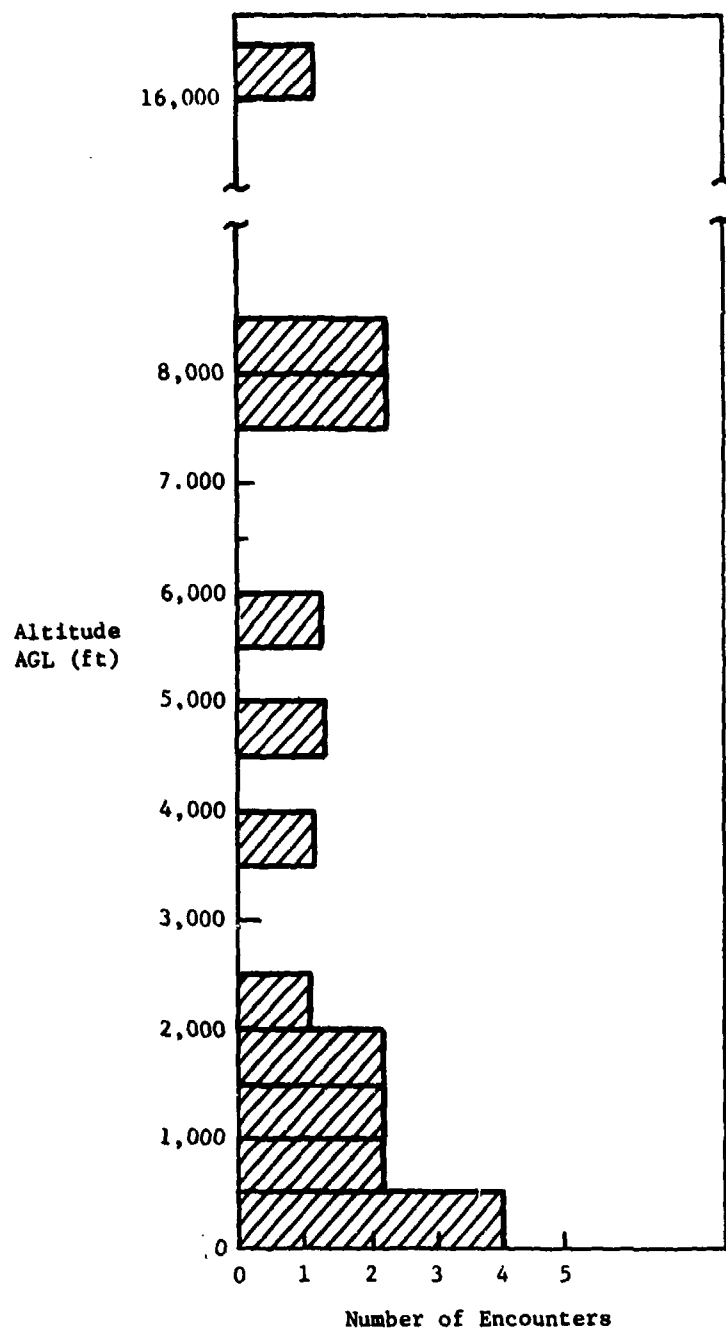
FIGURE 5-1
ALTITUDE DISTRIBUTION OF THE 19 ENCOUNTERS

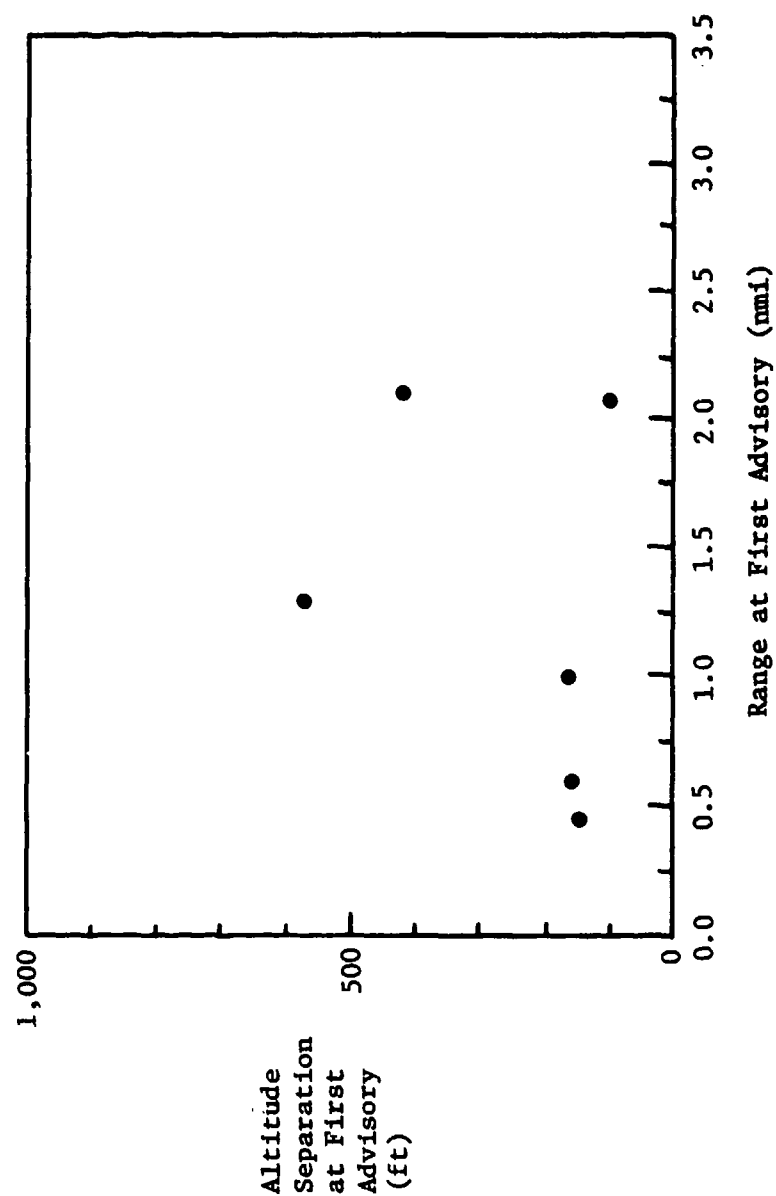
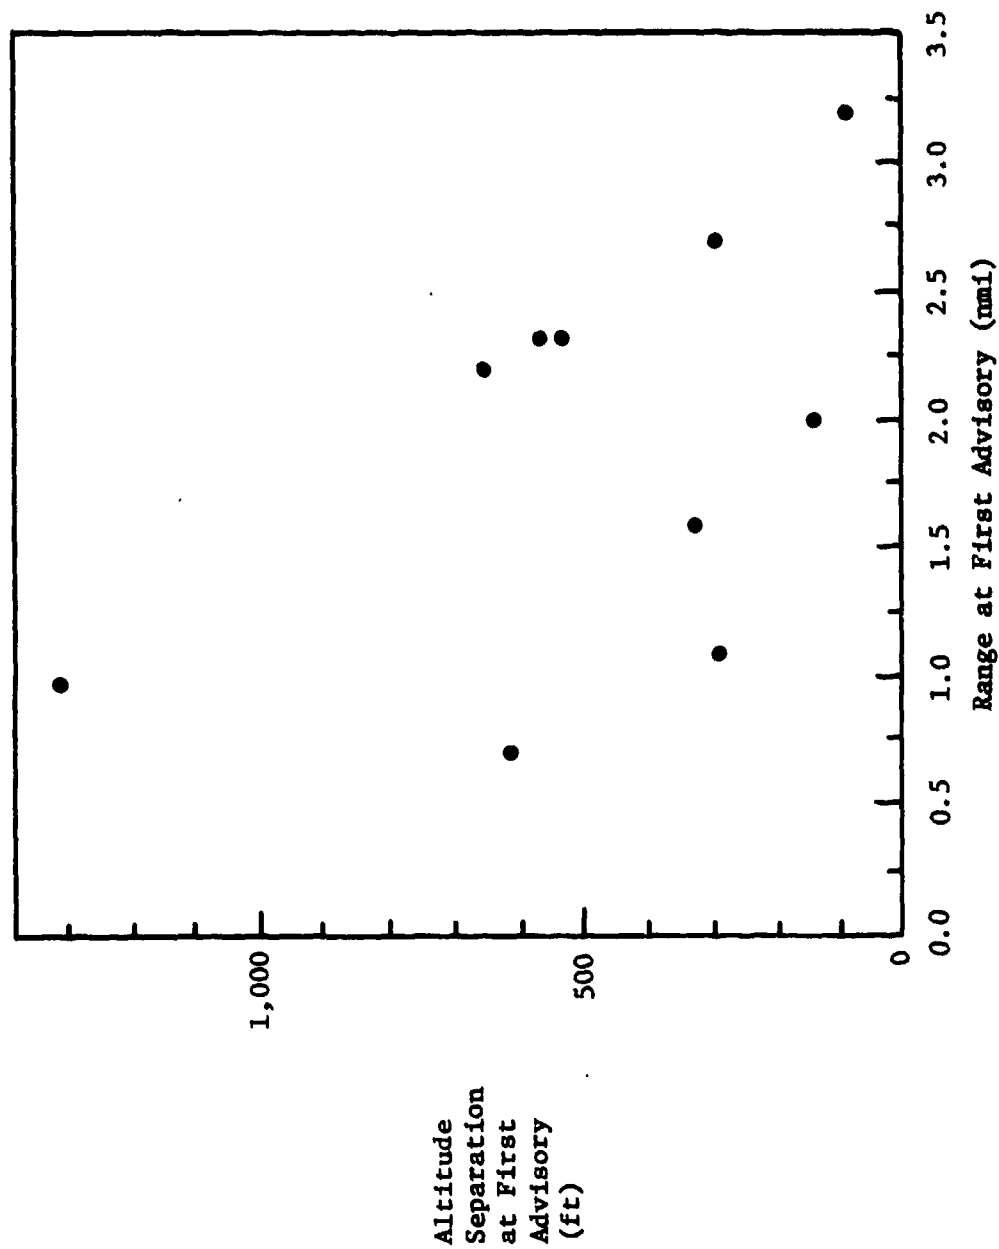
Figures 5-2 and 5-3 provide some data relevant to the question of whether the pilot may have visual contact with the intruder

FIGURE 5-2
SEPARATION AT FIRST ADVISORY FOR ENCOUNTERS IN SENSITIVITY LEVEL 3

FIGURE 5-3
SEPARATION AT FIRST ADVISORY FOR ENCOUNTERS IN SENSITIVITY LEVEL 4

at the time of the BCAS alert. It is noted that the range at time of alert is greater than 2 nmi for several of the encounters. Depending on the size of the intruder aircraft, the encounter geometry, and the visibility conditions, it is expected that a pilot would not have visual contact at the time of alert for some of these encounters.
